*The
Art Glass
Restoration
at*

Elstowe Manor, Elkins Park, PA
2013

Work preformed by craftsmen at Castle Studio, Inc.

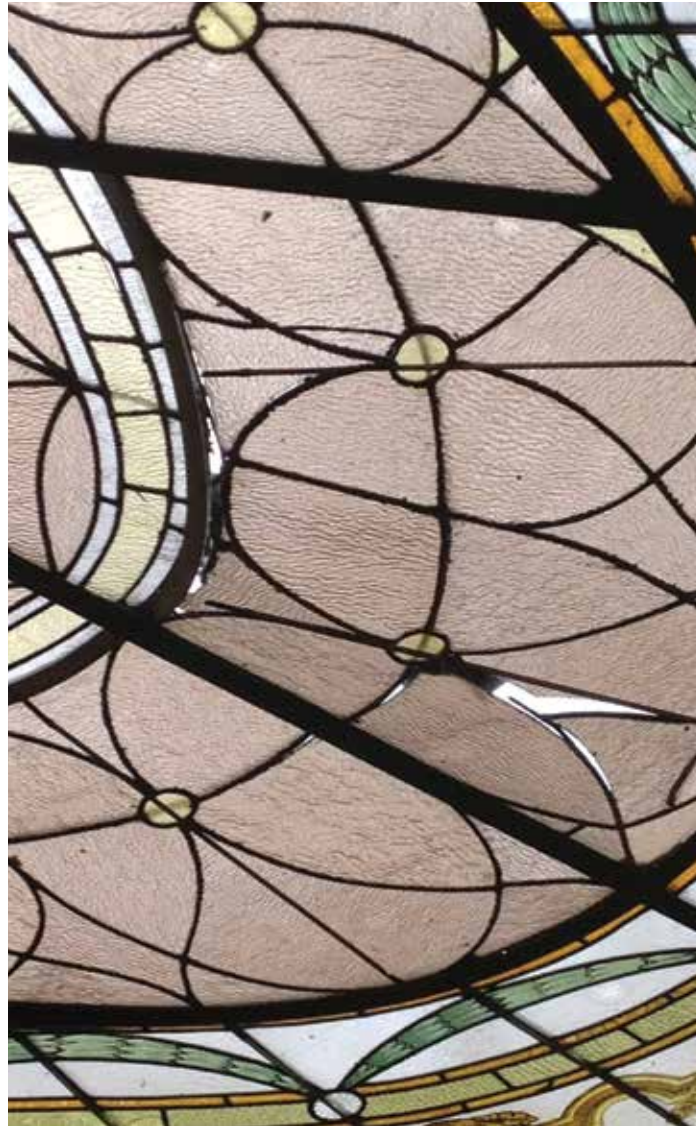
The current bar design did not offer the proper support that a stained glass ceiling requires. Many of the support bars had released from their panels, allowing gravity to take its toll and begin to buckle the lead-work.

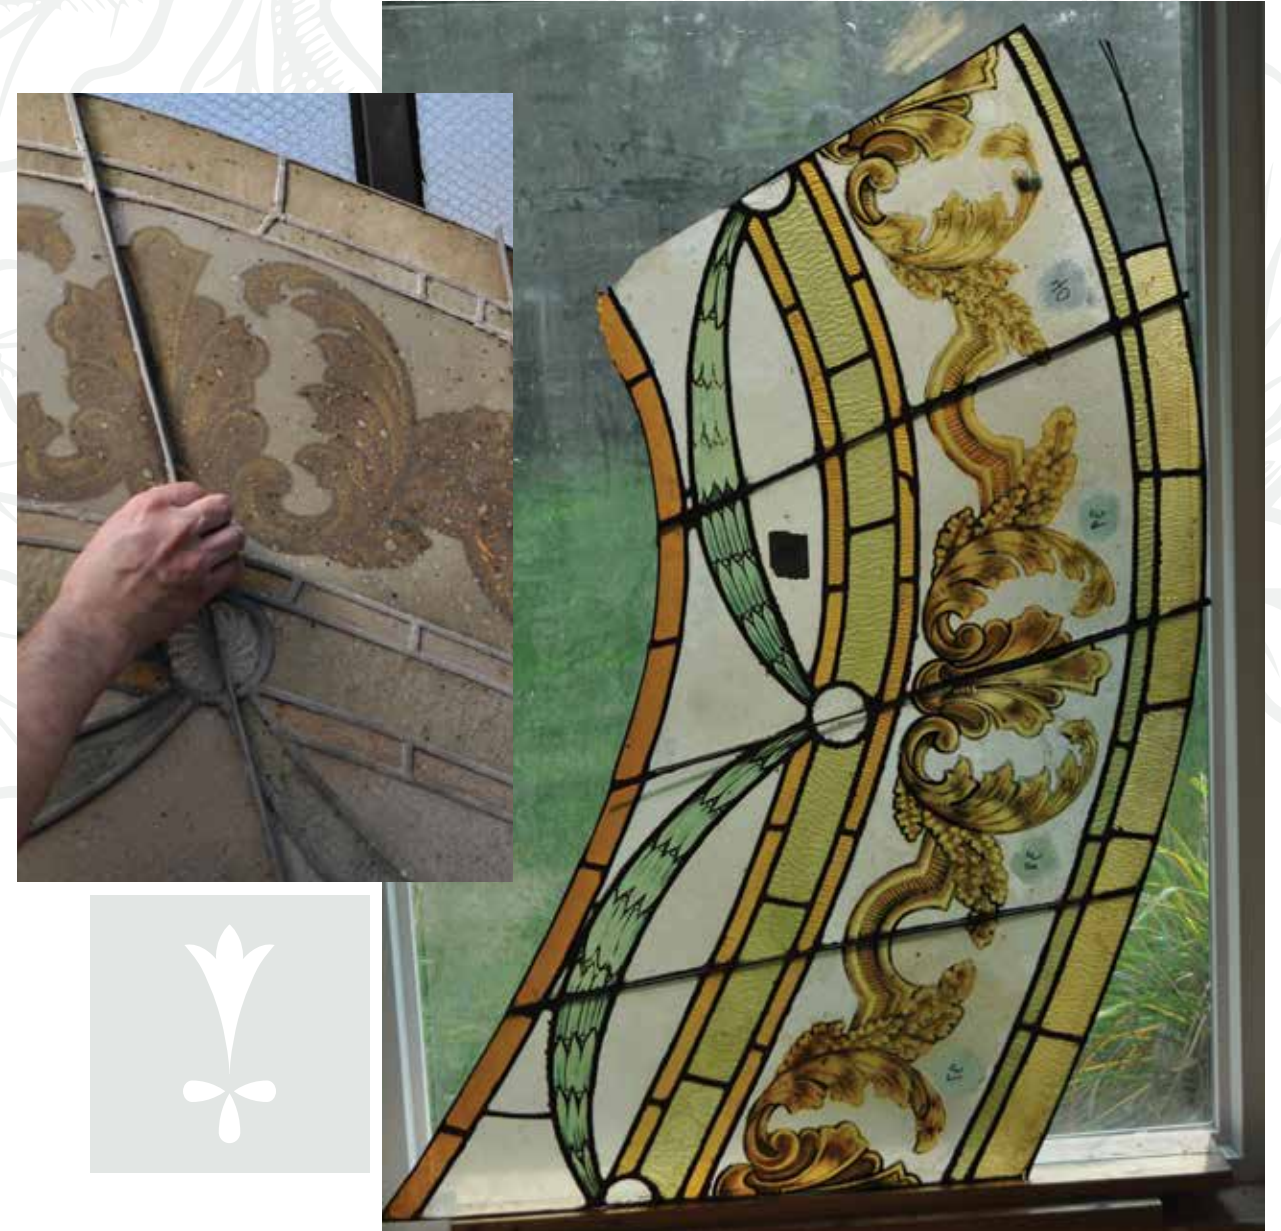
The entire painted perimeter border design had decayed to a point where the original design was barely noticeable. Several of these painted sections had already fallen to the floor and had been replaced with cardboard.

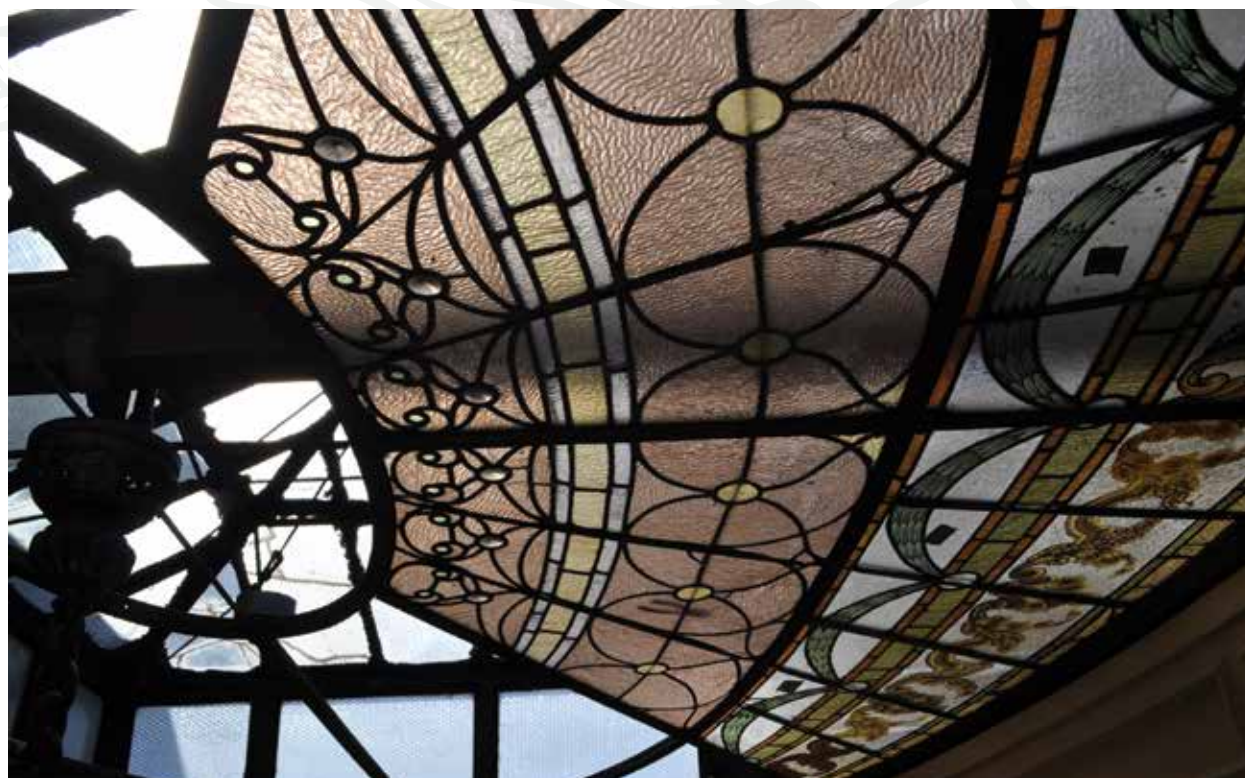
Immediate attention was required to save this treasure. Scaffolding was erected to the height of 25 feet with a full deck below the ceiling. We then catalogued each section of stained glass ceiling and proceeded to remove the individual panels from the steel frame. Unfortunately, the steel frame was bolted together at the intersections of the matrix. These bolts prevented the individual panels from sitting on the steel “T bars” in the corners.

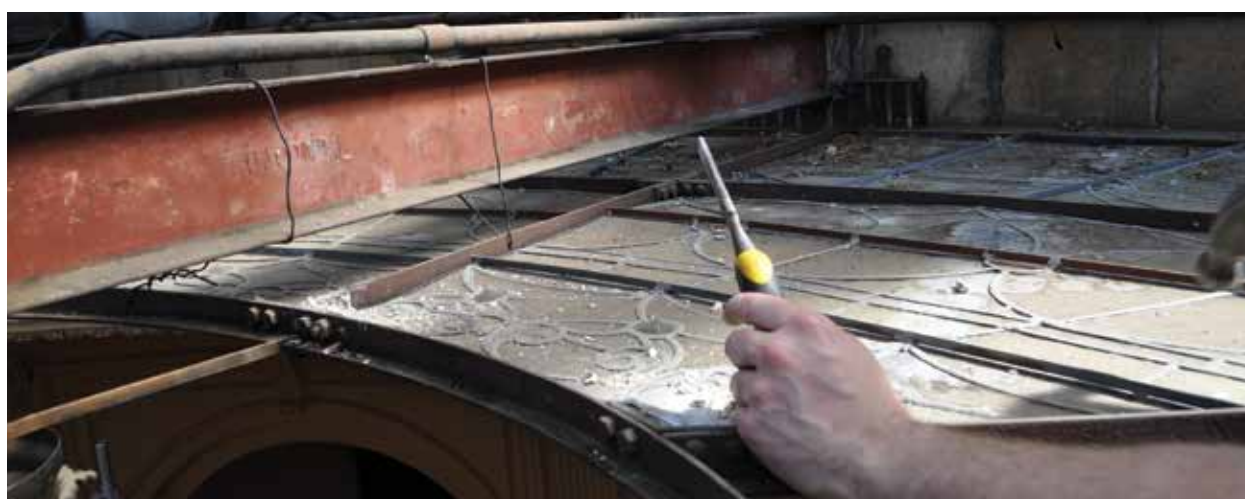
The original installers of the ceiling simply removed the lead and portions of the glass in the corners of the panels to allow each section to pass the bolts. Glazing compound was used to hide any damage caused, which hardened over time and now needed to be removed with a chisel and hammer.

The window sections once removed were carefully lowered to the balcony level below, where a craftsman could take them to Elstowe's dining room to await restoration. Now that the panels were removed, it became necessary to cut a plywood template for each panel that identified the location of the bolts. The templates, in conjunction with the rubbings, allowed us to build the new sections to their new shapes. These new shapes will pass easily by the bolts and will prevent any on site damage during the re-installation.

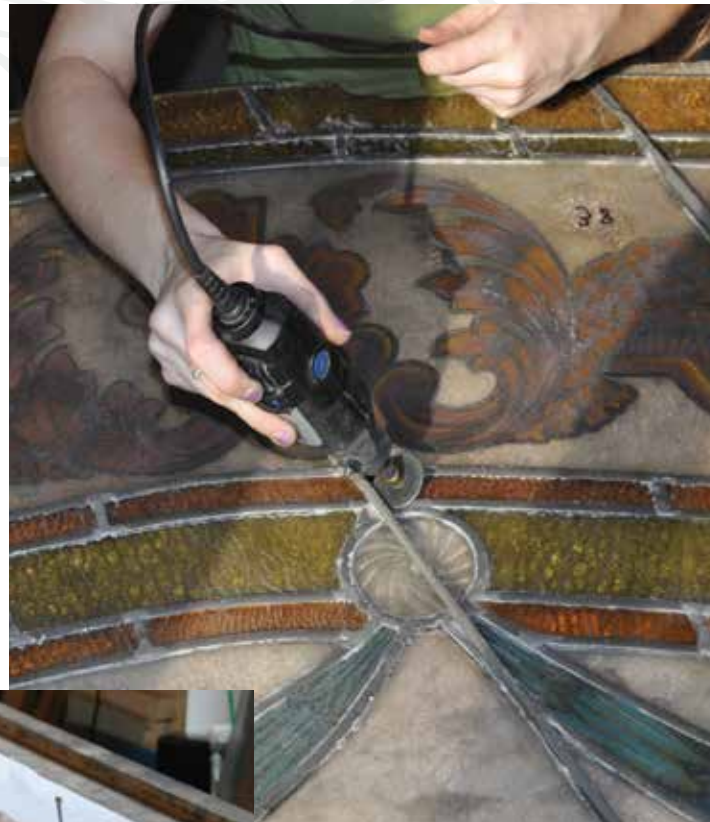
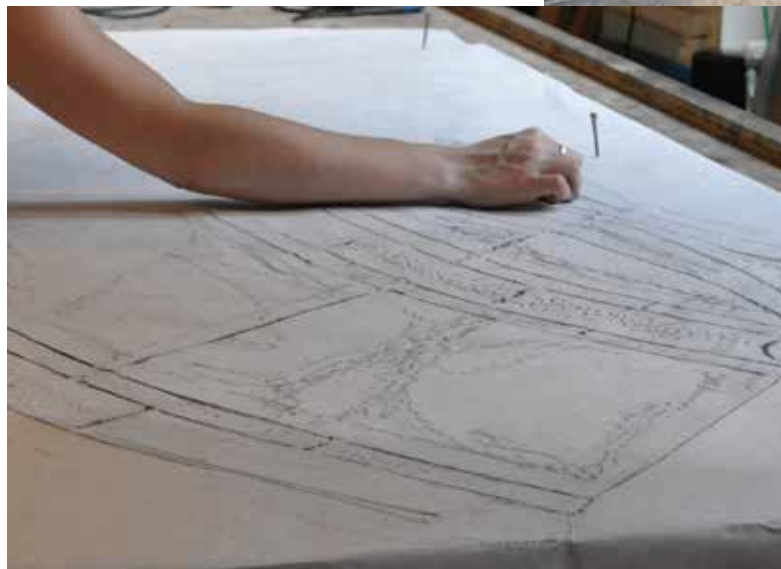
After cutting the support bars loose, a rubbing of each panel was taken to properly document the original lead matrix.

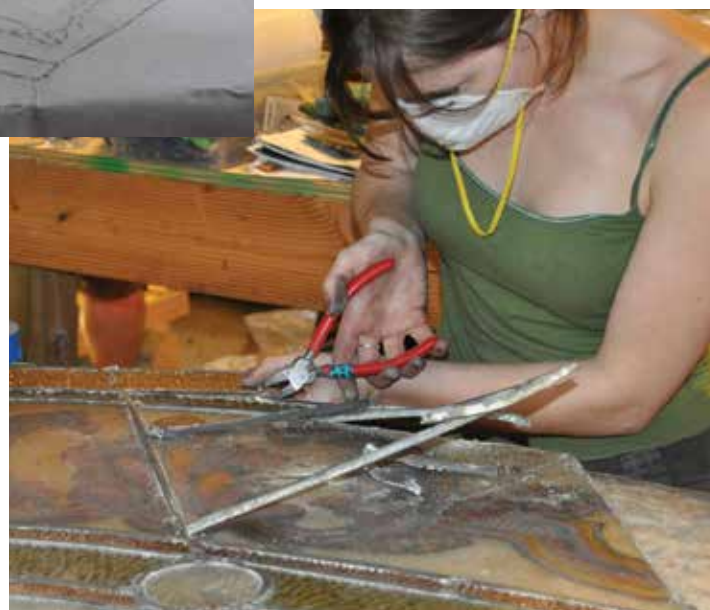
After the panels were disassembled, each piece of glass was cleaned and placed on a tray to await fabrication.

During this phase, broken glass was replaced with an appropriate match. Any decayed painted pieces were replicated and added to the trays prior to the re-leading process.

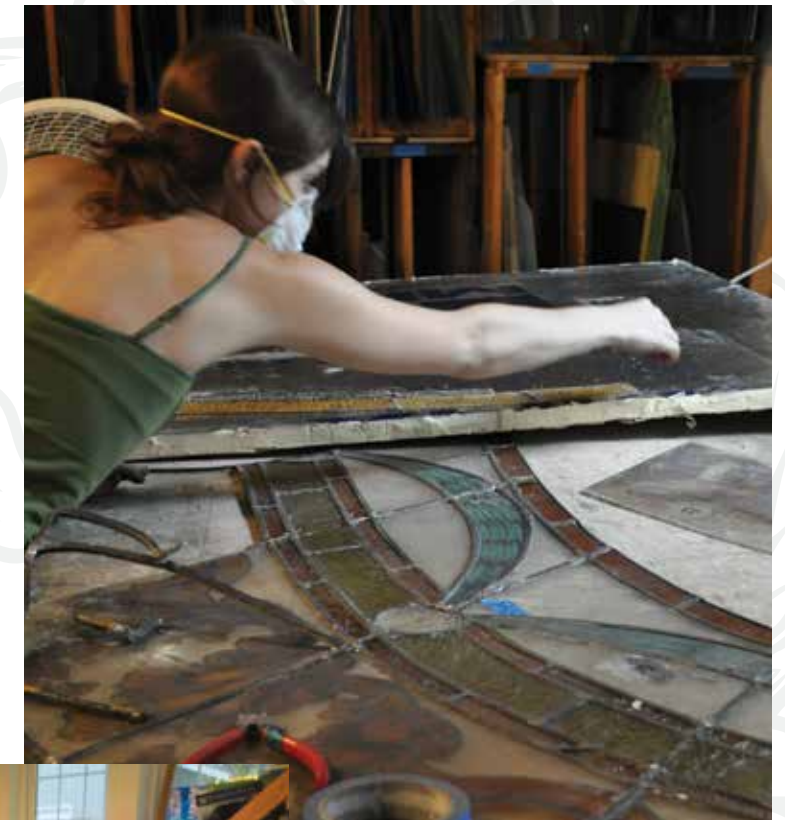
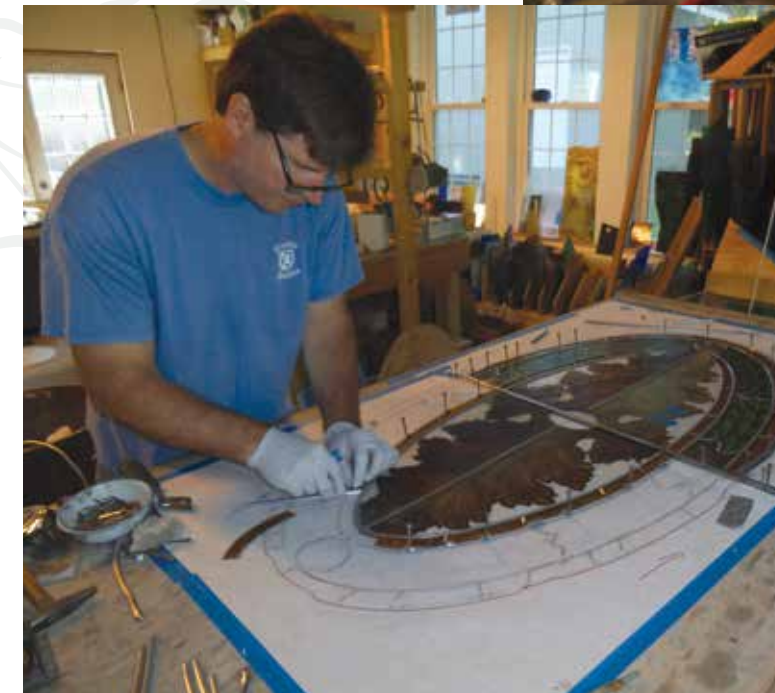
Each panel was then re-leaded using a special lead alloy made for this project.

This alloy offered us a stiffer lead coming, which in the long run, will help the ceiling last longer.

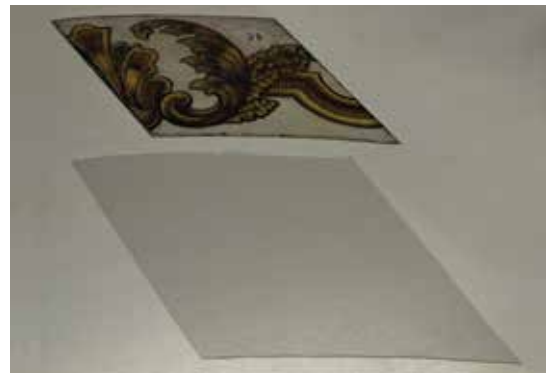
1. A new glass blank is cut to match the pane being replicated.

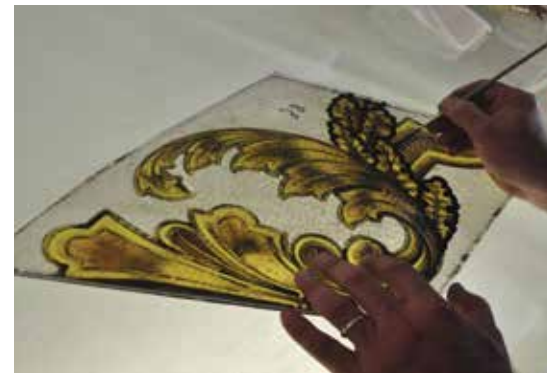
2. The glass blank is placed on top of the original and the dark lines are traced with a brush by hand.

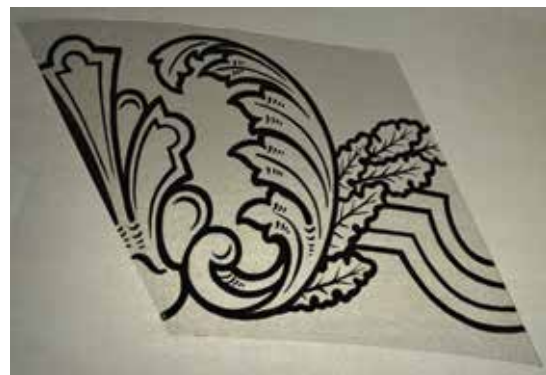
3. This is a completed tracing of the original.

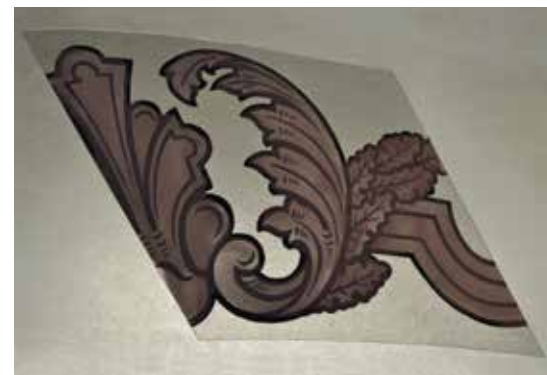
4. This is the first matte coat over the tracing.

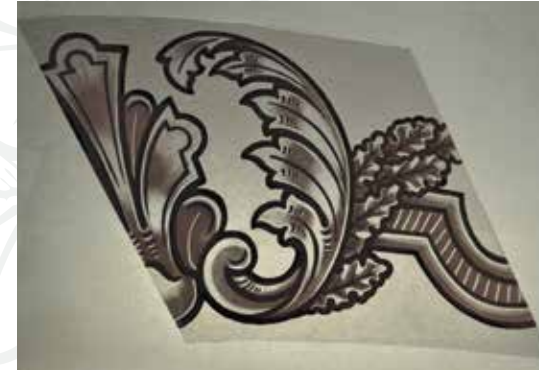
5. The matte coat is then dry brushed to reveal the highlights.

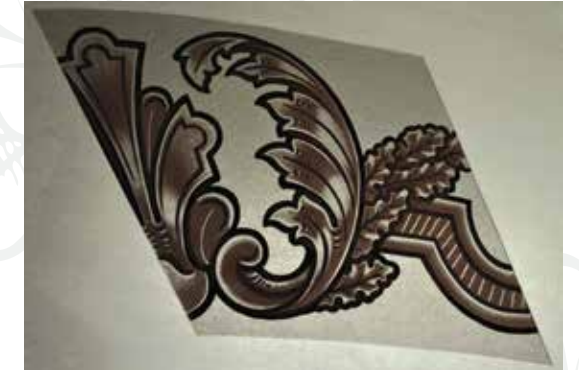
6. The second matte coat is applied and the highlights are again restored using a dry brush.

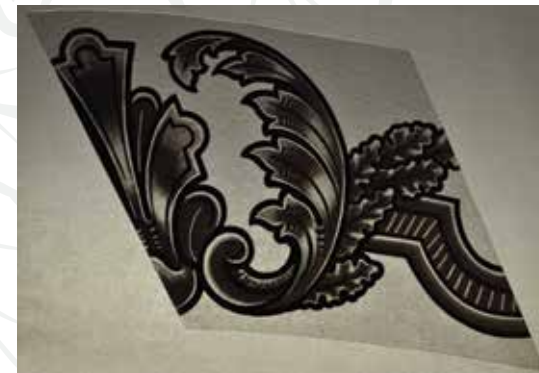
7. The third coat is applied, this time a dark stipple type of finish and the highlights are restored.

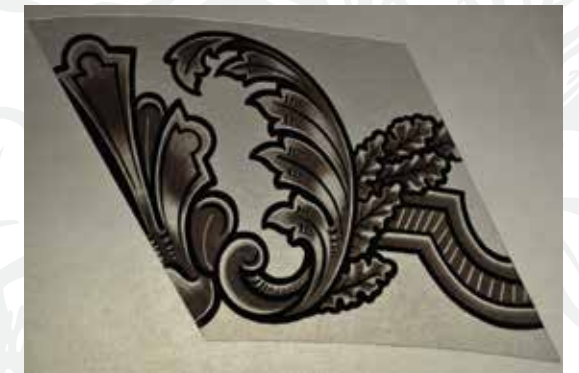
8. This is the finished piece prior to the silver stain.

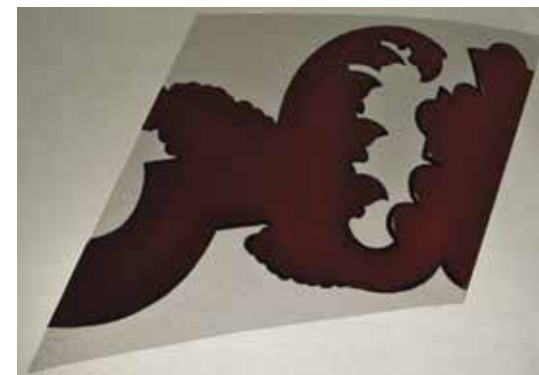
9. Silver stain is applied to the back of the piece and fired to 1000 degrees.

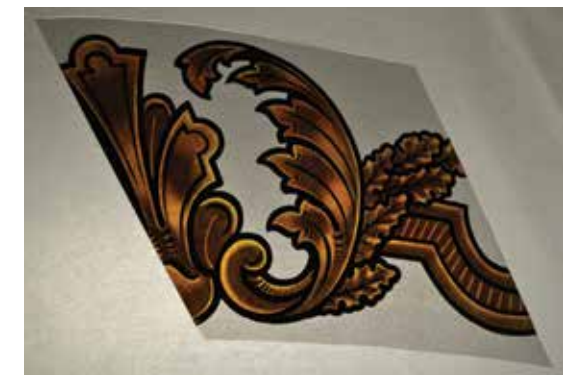
10. After a total of 5 firings, the finished pieces is ready.

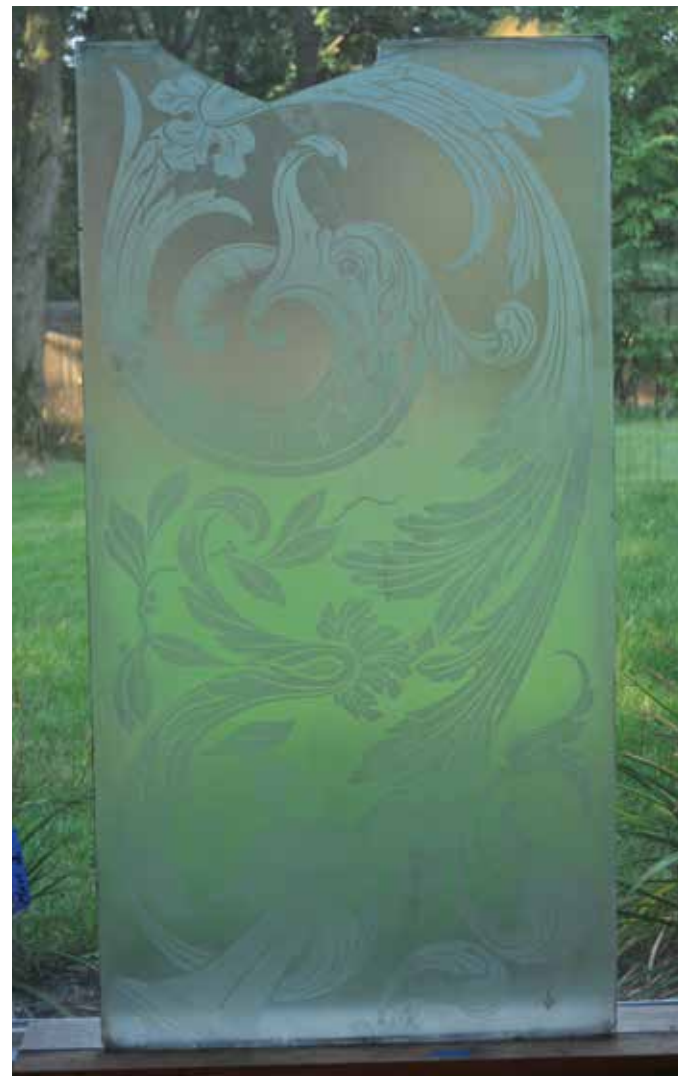
We decided to catalogue and lower the glass panels to the floor for cleaning. However, removing the glass panels was not without some difficulty. Each panel had been secured with small wooden blocks on the top edges of the glass.

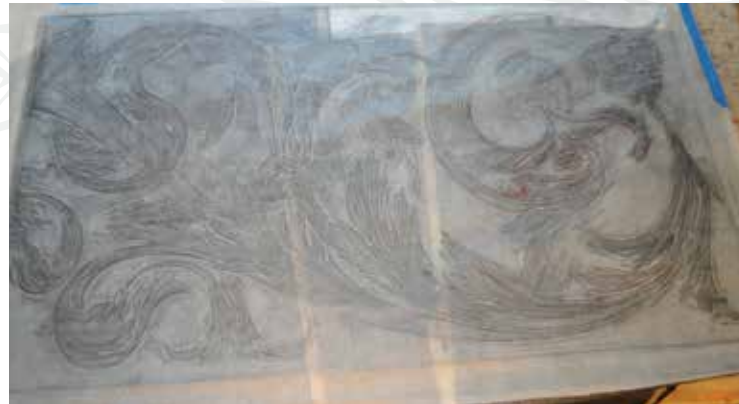
The first step to replicating the glass panels was to make a tracing of an original panel with the same design.

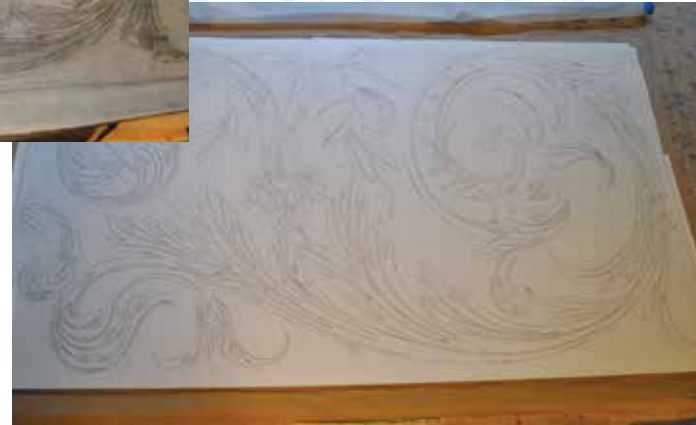
The tracing was then transferred to a new acid washed blank panel that was covered with a 4 mm sandblast resist. We then used an exacto knife to cut out the design and remove the resist to expose the glass for sandblasting.

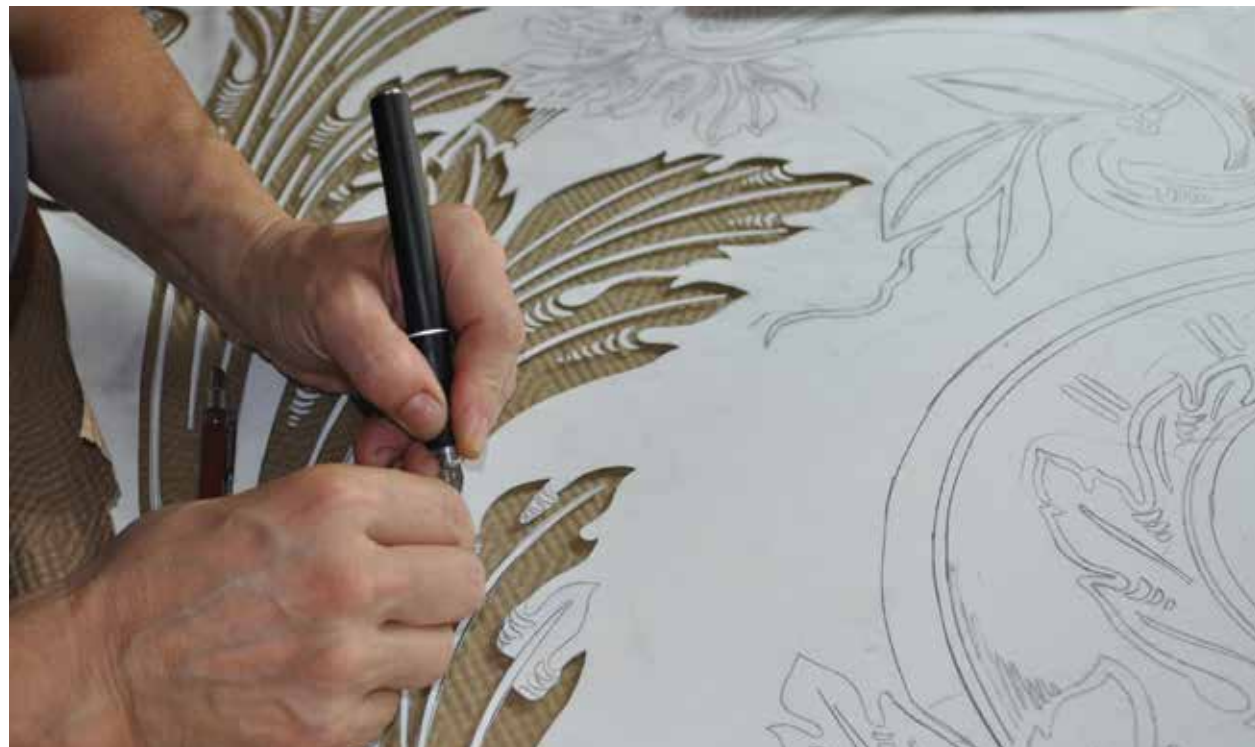
After the designs were completely cut out, they were sandblasted to achieve the new two tone design of the original panels. The combination of the acid washed glass and the sandblasted design provided the new two tone appearance.

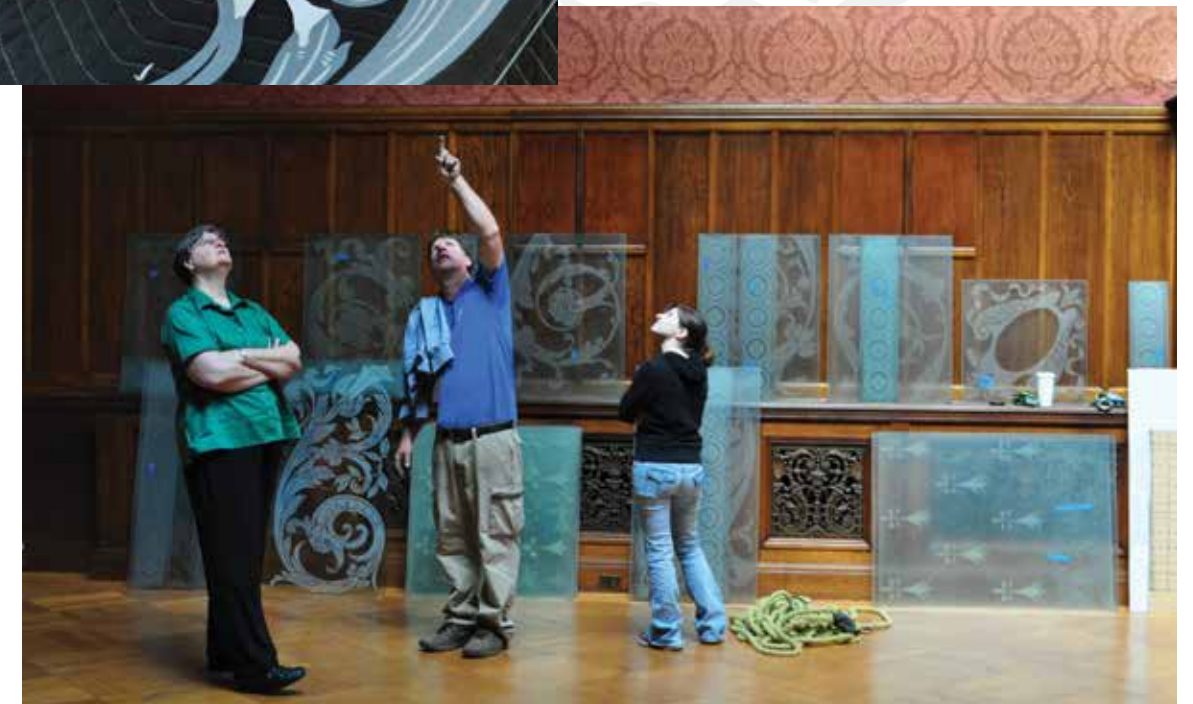
All remaining sandblast resist was scraped off and the new panels emerged for installation in their new home.

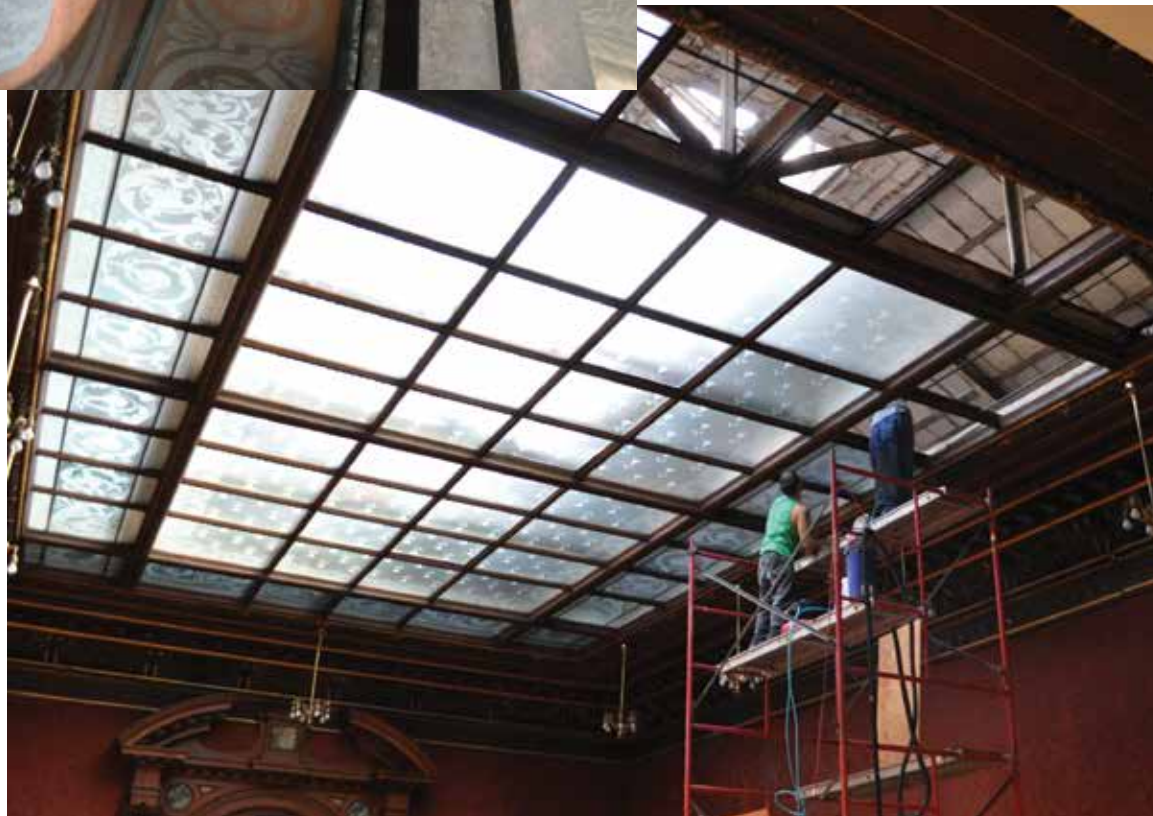
The wooden blocks were reinstalled around the edges of the glass.
